West Beach, Hayling Island

Coastal Change between Inn on the Beach and Hayling Golf Club – January 2020

West Beach: Erosion Risk Projections

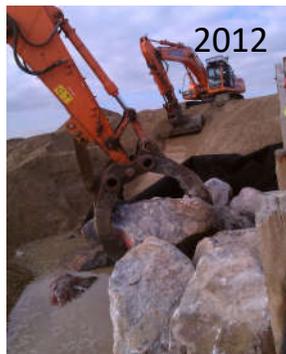
2012

- Constructed in 1976. Maintained by HBC but now past its design life. Partial collapse in 2012.
- Remaining Revetments – while functional and not of a H&S concern they will remain. They are routinely inspected.
- When this situation changes (which would be expected in the next 2-5 years, or in response to a significant storms) the affected sections will be removed.

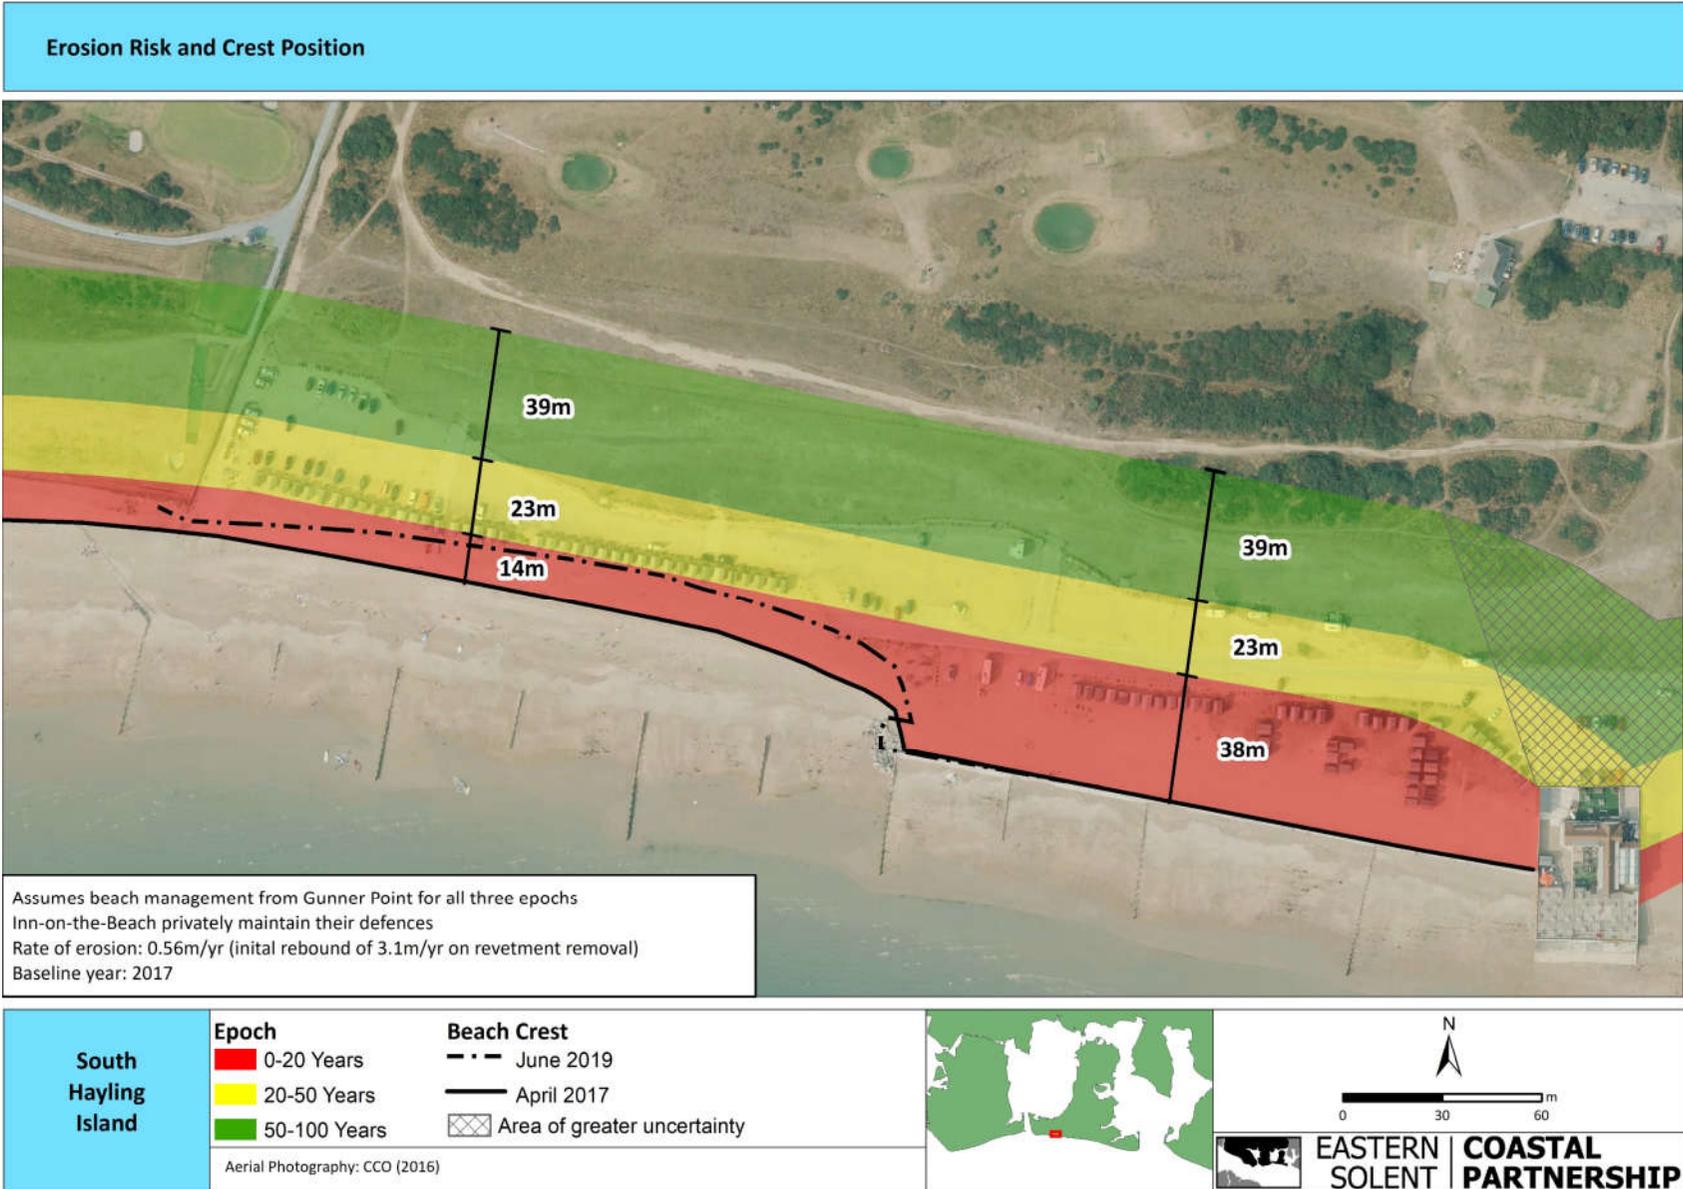
West Beach: Current Situation

- Erosion has occurred at a greater rate than predicted in 2017. We are well into the Red Risk Zone. Monitoring is ongoing.
- The beach has remained more stable at the western end at the Hayling Golf Course.
- Beach material could not be recycled from Gunner Point in 2019, therefore a haul route was not established along West Beach. This was not considered in the predictions.
- Increase in high magnitude swell events and largest run-up in 15 years recorded since 2017.

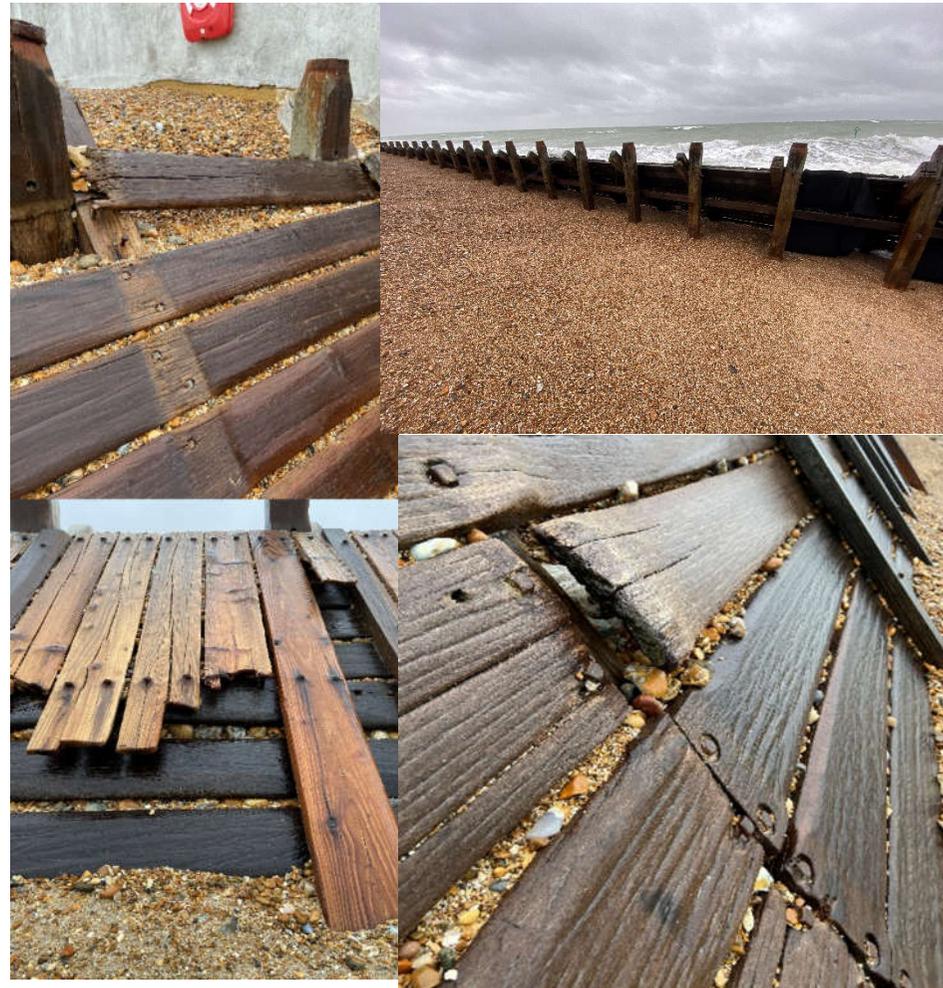
- Revetment constructed in 1976 (44 years ago).
- CIRIA (2004) guidance Tropical Hardwood: “Minimum expected life expectancy of 25 years”.
- West Beach is an aggressive environment. Despite maintenance, the structure has far exceeded its design life.
- HBC conducts routine inspection and maintenance of coastal assets.
- Repairs are now limited to H&S measures.
- Structure vulnerable to future storm damage.

- Once the coastal defences reach the end of their serviceable life or become a health and safety risk, the structures should be removed and the beach allowed to evolve naturally.
