West Beach, Hayling Island

Coastal Change between Inn on the Beach and Hayling Golf Club – January 2020

West Beach: Erosion Risk Projections

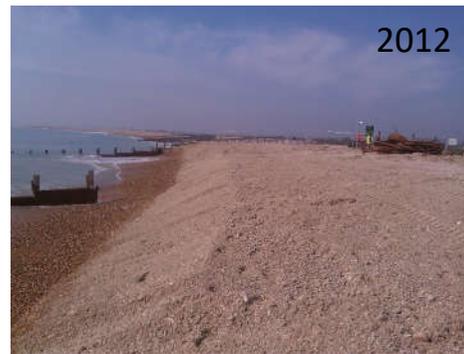
2012

- Constructed in 1976. Maintained by HBC but now past its design life. Partial collapse in 2012.
- Remaining Revetments – while functional and not of a H&S concern they will remain. They are routinely inspected.
- When this situation changes (which would be expected in the next 2-5 years, or in response to a significant storms) the affected sections will be removed.

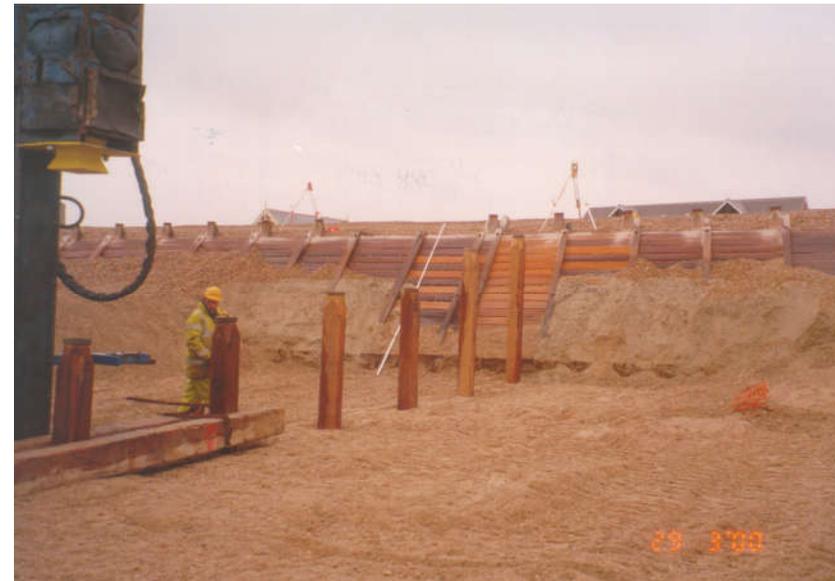
Constructed: 1976
Original design life: 20 – 30 years
Form: Timber sloping breastwork,
sheet pile toe, timber groynes
Construction costs: £670,000
Maintenance costs: £490,000
TOTAL COSTS: £1.16 M
(ALL COSTS CORRECTED TO 2007 VALUES)

- Revetment constructed in 1976 (44 years ago).
- CIRIA (2004) guidance Tropical Hardwood: “Minimum expected life expectancy of 25 years”.
- West Beach is an aggressive environment. Despite maintenance, the structure has far exceeded its design life.
- HBC conducts routine inspection and maintenance of coastal assets.
- Repairs are now limited to H&S measures.
- Structure vulnerable to future storm damage.

- Remove damaged sections of breastwork
- Remove unsafe beach access points

- Remove sections posing Health & Safety risk to public
- Relocate vulnerable beach huts

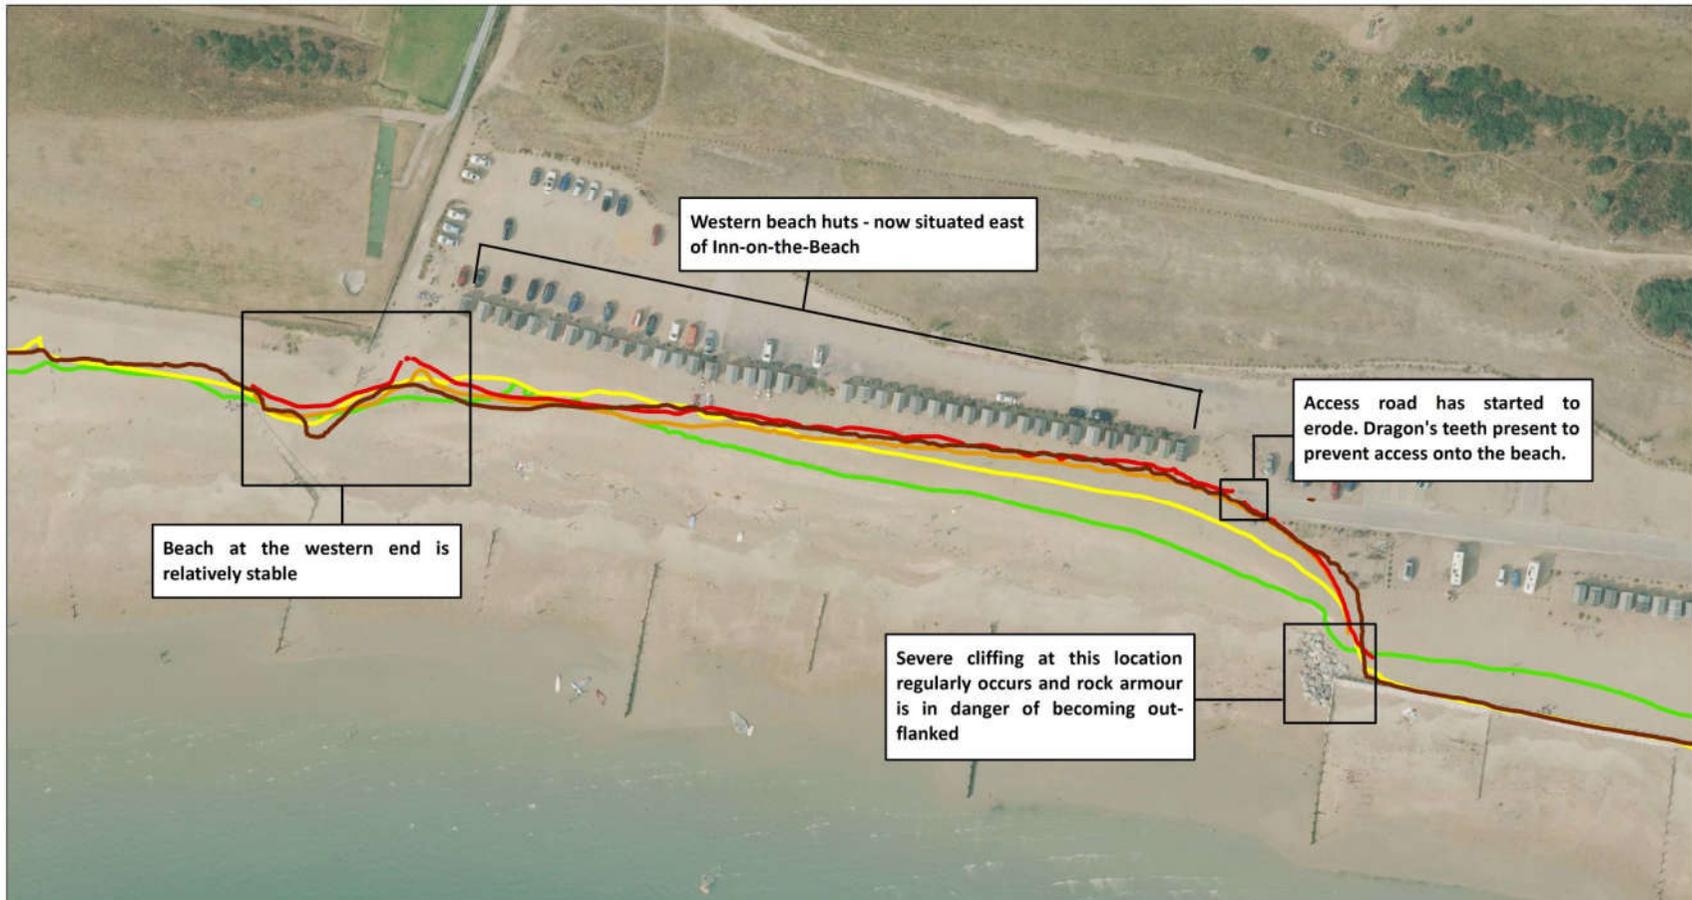
West Beach: Current High Tide Line

- June 2019
 - January 2019
 - November 2018
 - April 2018
 - April 2017
- The beach crest is assumed to have an elevation of 4.3mOD.

- Erosion has occurred at a greater rate than predicted in 2017. We are well into the Red Risk Zone. Monitoring is ongoing.
- The beach has remained more stable at the western end at the Hayling Golf Course.
- Beach material could not be recycled from Gunner Point in 2019, therefore a haul route was not established along West Beach. This was not considered in the predictions.
- Increase in high magnitude swell events and largest run-up in 15 years recorded since 2017.
